# FUTURE FISHERIES IMPROVEMENT PROGRAM

## BIENNIAL REPORT

Summary of program activities for the period November 1, 2016 to October 31, 2018

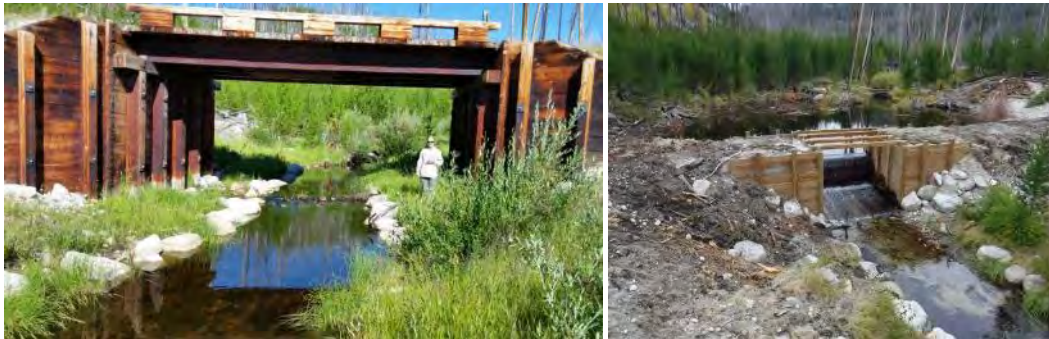
#### Bender Creek fish barrier (001-2017)

Bender Creek (Beaverhead County) is a tributary to Johnson Creek and the North Fork of the Big Hole River. It supports a non-hybridized (pure) population of westslope cutthroat trout, but they were isolated to a less than 0.25-mile section of stream. Brook trout outcompeted cutthroat trout in much of the stream and were moving into the headwaters area. This project installed a treated lumber fish barrier immediately upstream of a bridge crossing (Figure 5). Now that the barrier is installed, cutthroat trout will be salvaged, and brook trout will be removed using rotenone. Westslope cutthroat trout will be returned to the stream and four miles of habitat would be open for the conservation of this species. **COMPLETED; \$6,000, FWP.**

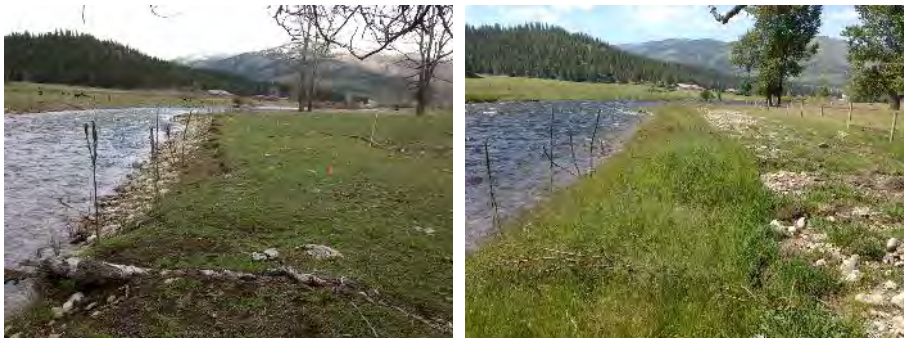
to reduce sediment and thermal loading by increasing riparian vegetation and encouraging point bar development and sinuosity. Riparian fencing was installed along 2,000 feet of the stream, nursery plants and shrub transplants were used, and browse protectors were installed (Figure 6). The fencing configuration created a buffer and restoration activities should enhance natural recruitment and encourage bank repair. **COMPLETED; \$9,000, BITTER ROOT WATER FORUM.**

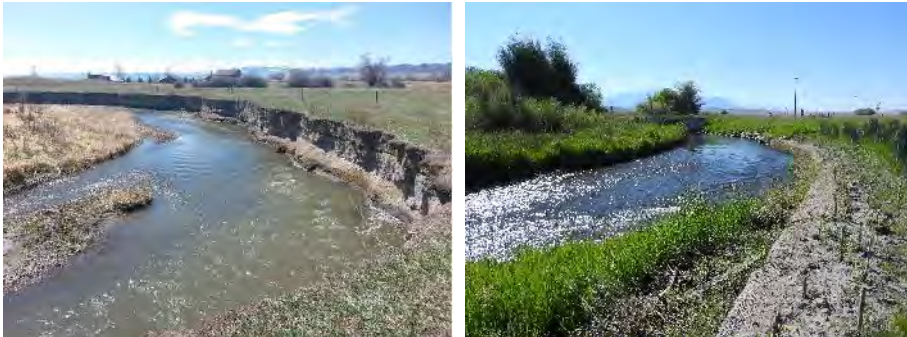
Lower Jack Creek (Madison County), near the confluence with the Madison River, supports populations of brown trout and rainbow trout and has been the site of active channel migration and heavy erosion. This location was historically dynamic and experienced alterations such as channel straightening, placement of carbody bank armor, and unfavorable management practices (Figure 7). This project took place on three private property holdings with 1,200 feet of stream. Four actively eroding bank sites were restored with bankfull benches, sloping, and native plantings. **COMPLETED; \$10,014.48, MADISON CONSERVATION DISTRICT.**

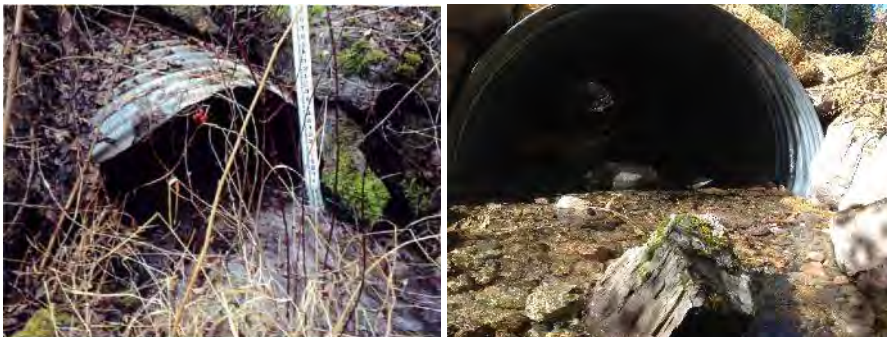
## Marshall Creek fish passage (008-2017)

Marshall Creek (Missoula County) is a tributary to the Clark Fork River located just upstream of the City of Missoula. It is an important source of natural westslope cutthroat trout recruitment and an area with a large angling population. This project continued fish habitat enhancement work in the lower watershed by replacing two undersized culverts that acted as velocity barriers during moderate and high flow periods with larger counter-sunk culverts that can accommodate 100-year flows and bankfull channel width (Figure 8). The goal was to enhance upstream fish passage for adult and juvenile cutthroat trout in an established spawning and rearing area.

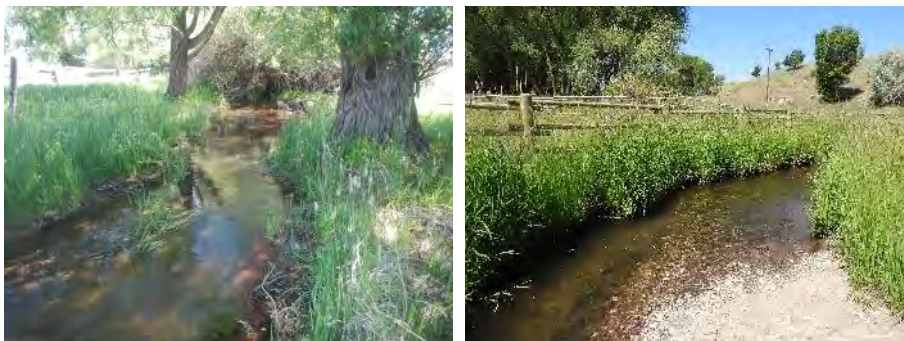
Moore's Creek (Madison County) is a tributary to the Madison River immediately west of Ennis. The stream is believed to support rainbow, brown, and brook trout. The stream and riparian areas were highly degraded due to past management practices and channel manipulations and water quality is impacted by *E. Coli* and sediment. This project moved the stream channel from its position as a straight, confined channel to a location where the stream could have proper dimensions and function (Figure 9). The project improved riparian areas and water quality through fencing, riparian plantings, livestock management, and irrigation improvement.

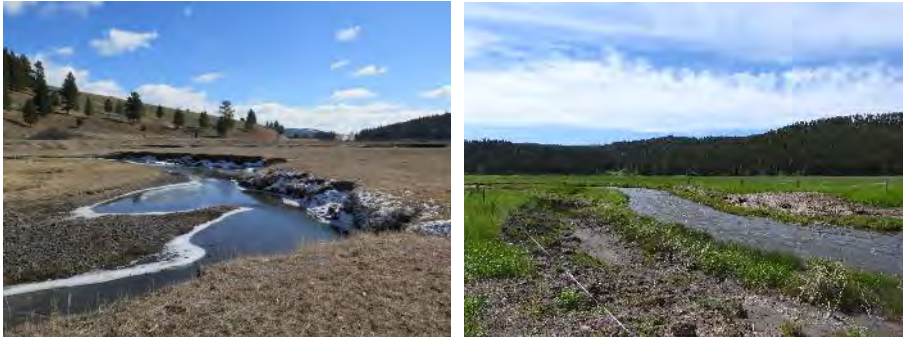
### Nevada Creek channel restoration (011-2017)

Nevada Creek (Powell County) is a tributary to the middle Blackfoot River and supports populations of westslope cutthroat trout, rainbow trout, and brown trout. In the project area, the stream was historically straightened, and a non-functional riparian area caused the channel to erode and downcut. In 2010, an adjacent channel restoration project reduced sediment, increased stream complexity, improved riparian condition, and created fish habitat that resulted in increased trout abundance. This project is considered phase two and continued the restoration downstream. The channel was restored to proper dimensions, plantings and bank treatments were used to improve the riparian areas, and fence was installed to operate a grazing management system (Figure 10). **COMPLETED; \$47,000, BIG BLACKFOOT CHAPTER OF TROUT UNLIMITED.**

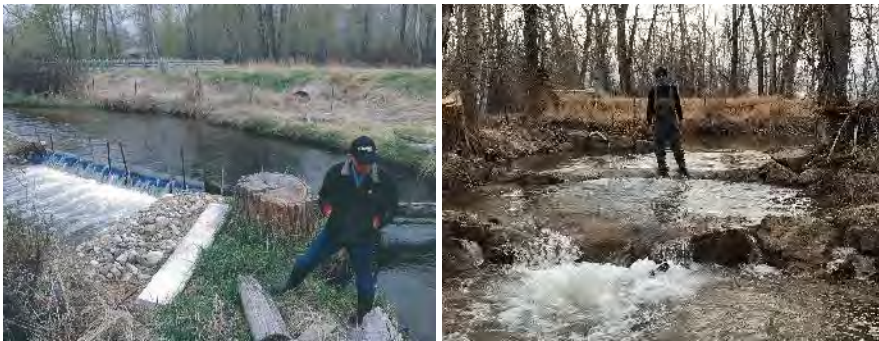
### Racetrack Creek Johnson diversion replacement (014-2017)

Racetrack Creek (Powell County) is a tributary to the Clark Fork River that supports populations of brown trout, mountain whitefish, westslope cutthroat trout, longnose sucker, and slimy sculpin. The project area was limited by dewatering in mid-to-late summer and high temperatures. Other complementary projects focused on improving instream flows, so this project built on those efforts by providing fish passage to the habitat features upstream to the Berg diversion (1.6 miles) and downstream to the lower, cold-water (groundwater) area of the creek. This project replaced an irrigation diversion that blocked upstream fish passage and entrained fish with a rock weir diversion that allows passage (Figure 11). The goal was to enhance fish passage and eliminate entrainment in a high priority watershed. **COMPLETED; \$22,880 awarded / \$18,661 expended, CLARK FORK COALITION.**

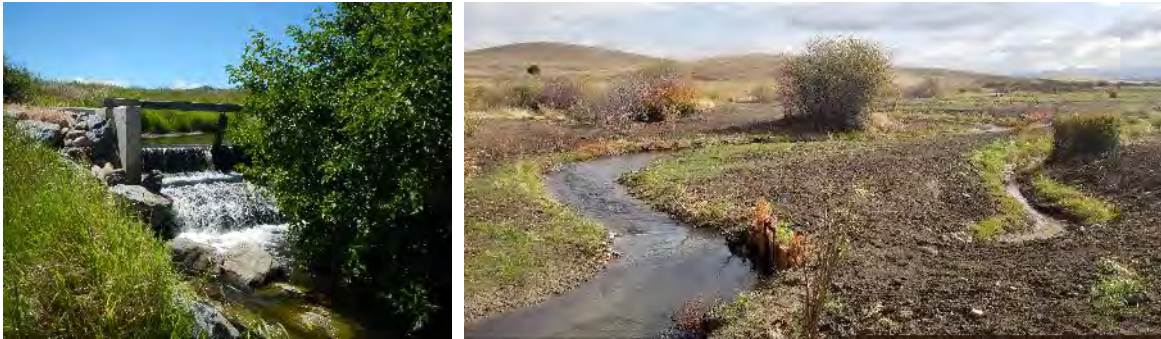
Valley that included approximately 2.2 miles of Sevenmile Creek. The stream was heavily impacted by riparian clearing, intensive grazing, flow diversion, and channelization. As part of a larger project to improve the property, this project addressed a diversion that blocked fish passage and was in danger of having an avulsion. This project created 2,600 feet of new stream channel, created wetland areas in the old channel, and replaced the irrigation diversion (Figure 12). A functional floodplain was produced, fish habitat was created, and legal use of the water right was retained. **COMPLETED; \$21,363; PRICKLY PEAR LAND TRUST.**

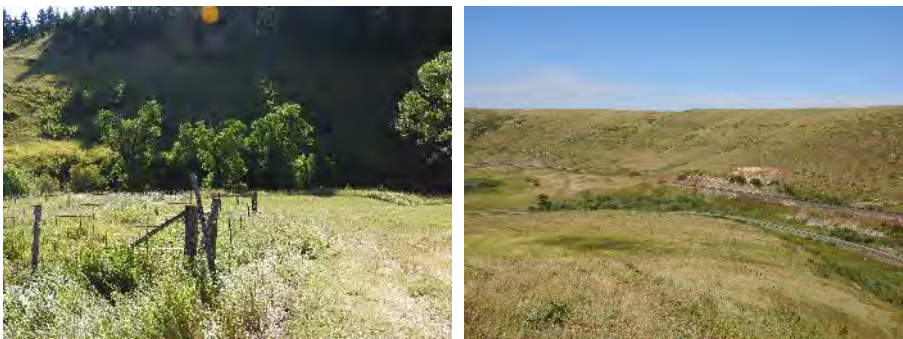
### **Williams Creek riparian fencing (018-2017)**

Williams Creek (Judith Basin County) is a tributary to Big Otter Creek near Raynesford. It supports populations of brown trout, brook trout, and rainbow trout. Cattle were able to access the stream, so this project installed riparian fencing to control livestock access, constructed a water gap, and developed a spring for off-stream water (Figure 13). The goals were to improve fish habitat through riparian growth, reduced sedimentation, and overall stream health. **COMPLETED; \$9,220, LANDOWNER.**

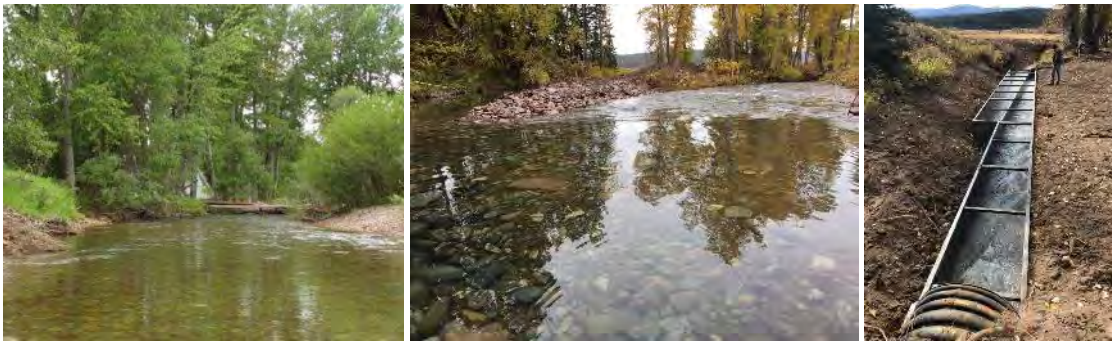
## Blackfoot River fish screen (020-2017)

The mainstem Blackfoot River is a tributary to the Clark Fork River and supports two imperiled fish species: bull trout and westslope cutthroat trout. This project was in an area that is considered a migratory area for both bull and westslope cutthroat trout and is considered a critical bull trout area. This project screened an irrigation diversion by installing a low-maintenance Farmers-style fish screen with a headgate to allow for hydraulic control (Figure 14). A limited amount of instream wood and willow plantings were installed along the river bank margin to protect the new infrastructure. The goal was to eliminate fish entrainment, improve migratory corridors, and allow for efficient irrigation practices. **COMPLETED; \$49,949 awarded / \$54,944 expended (10% overage), BIG BLACKFOOT CHAPTER OF TROUT UNLIMITED.**

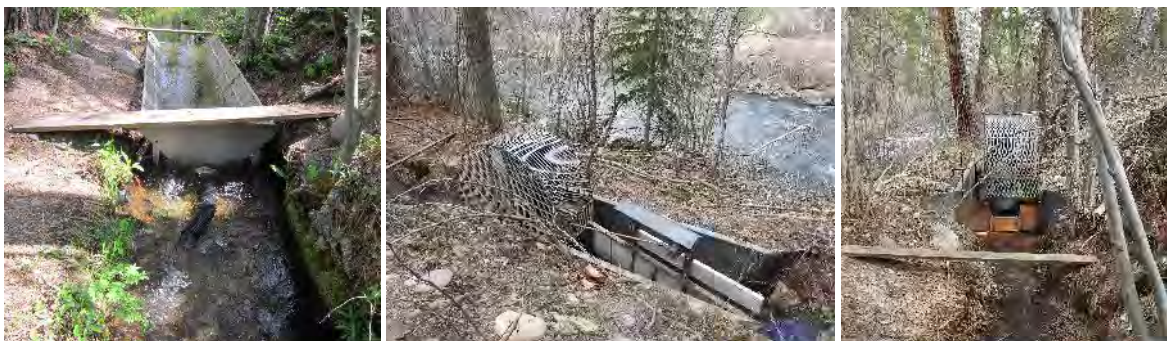
## Rattlesnake Creek Cobban fish screen (028-2017)

Rattlesnake Creek (Missoula County) is a tributary to the Clark Fork River that is a primary spawning tributary for both native bull trout and westslope cutthroat trout, as well as fluvial rainbow and brown trout. Rattlesnake Creek has several ditches, most of which were screened in 2002 with brencaill-type screens. The brencaill screen on the Cobban ditch did not function as intended; it required maintenance up to four times a day during high flow. The water users drilled holes in the screen to help alleviate the clogging. This project replaced the current screen with a vertical plate, paddlewheel-driven screen (Figure 15). The goal of the project was to prevent fish entrainment and increase spawning habitat for salmonids in the Rattlesnake Creek drainage. **COMPLETED; \$14,000, TROUT UNLIMITED.**

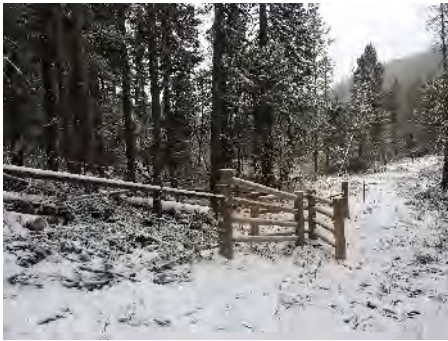
riparian area. This project installed 1.5 miles of wildlife-friendly fence will and restrict cattle grazing to 7-15 days (Figure 16). The goal was to create a permanent solution that will allow grazing and benefit riparian, stream, and fish habitat. Elliston Creek and the Little Blackfoot River are listed by the Department of Environmental Quality for sedimentation impairments and alteration to streamside vegetative cover in part due to grazing. **COMPLETED; \$11,880, U.S. FOREST SERVICE.**

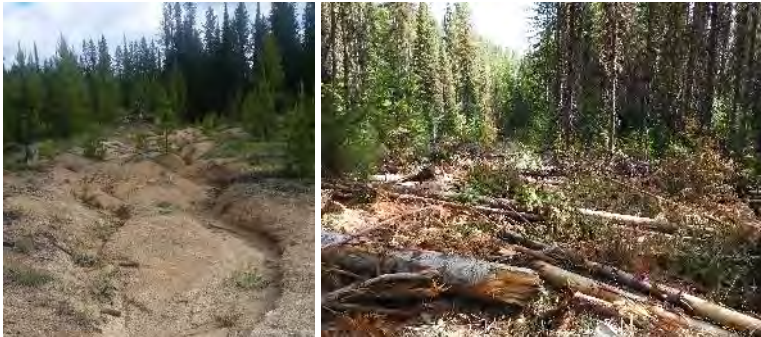
### **Granite Creek culvert removal and fish passage (005-2018)**

Granite Creek is a tributary to West Fork Lolo Creek and supports populations of westslope cutthroat trout, bull trout, mountain whitefish, brook trout, and brown trout (Missoula County). Located on the Lolo National Forest, this project addressed lands that were formerly under Plum Creek Timber Company ownership. The road network is extensive and there are many failing culverts. Since 2006, over 113 roads have been decommissioned, 51 major culverts were removed, and 10 culverts were upgraded (Figure 17). This project affected 15 miles of stream and retained public access. Granite Creek is listed as a sediment impaired stream by Montana DEQ. The goal was to improve watershed health, connectivity, and habitat for salmonids in the lower Bitterroot and Clark Fork Rivers. **COMPLETED; \$54,188, CLARK FORK COALITION.**

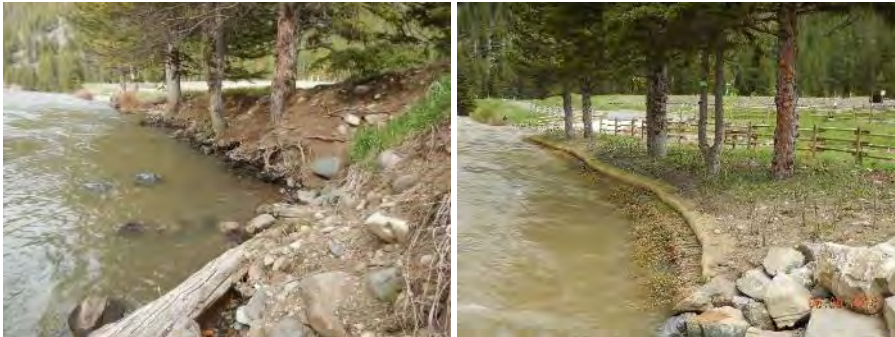
The Gallatin River is a tributary to the Missouri River that primarily supports populations of rainbow trout and brown trout (Gallatin County). This project is located on U.S. Forest Service property in the Gallatin Canyon, and enhanced streamside vegetation, added riparian fencing, improved trail systems, stabilized streambanks, and developed designated access sites for all user types. This included 145 feet of streambank stabilization with bioengineering techniques, almost 11,000 square feet of riparian plantings, 1,460 feet of riparian fencing, 1,000 feet of trails, a stairway to the river, boat ramp, kayak launch, and interpretive signs (Figure 18). Wild fish habitat is expected to be enhanced by rebuilding streambanks, enhancing streamside vegetation, installing riparian fencing, and focusing river access in specific locations. The goal was to reduce fine sediment and enhance riparian areas while providing safer and more directed access to the river. **COMPLETED; \$10,000, GALLATIN RIVER TASK FORCE.**

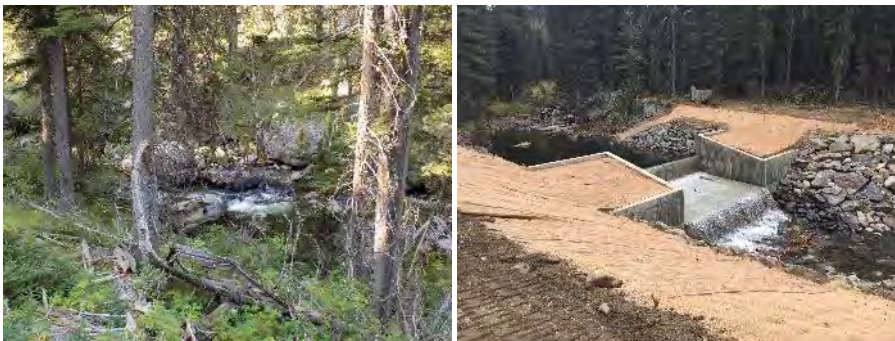
### North Fork Spanish Creek barrier supplement (028-2018)

North Fork Spanish Creek (Madison County) located on property owned by Turner Enterprises, Inc. aims to restore westslope cutthroat trout to 17 miles of historical stream habitat and 9 acres of high mountain lake habitat. The project would install a fish barrier on North Fork Spanish Creek, use piscicides to remove non-native brook trout and hybridized westslope cutthroat trout, and re-establish westslope cutthroat trout (Figure 19). This project is considered the best and largest opportunity to restore native westslope cutthroat trout in the in the Gallatin River sub-basin. This project was initially funded in 2016 (\$60,000), and this grant was a supplement based on higher than expected construction costs. **COMPLETED; \$27,500, LANDOWNER.**

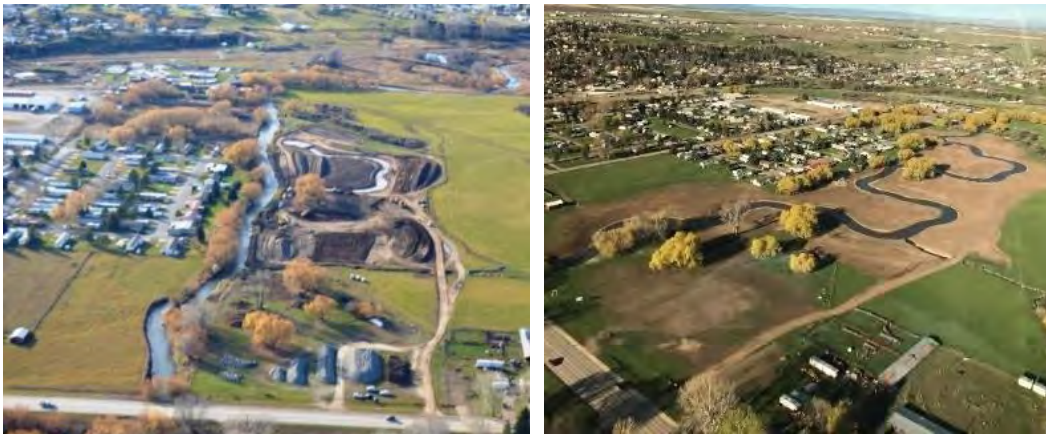
## **Big Spring Creek Machler restoration (028-2010 / 027-2011 / 001-2016)**

Big Spring Creek (Fergus County) supports a very popular rainbow trout and brown trout fishery. A reach of Big Spring Creek, located on property owned by Machler immediately downstream of Lewistown, was channelized in the 1960's, resulting in a straight and entrenched channel with degraded habitat characteristics (Figure 21). In part, this channelization project created the impetus for the ultimate passage of the Montana Natural Streambed and Land Preservation Act (310 law). The project returned meanders to the straightened channel and created a functional floodplain for 3,200 feet of the stream, resulting in the addition of about 1,200 feet of new channel. The project is located on a new FWP fishing access site with a permanent walk-in public easement.

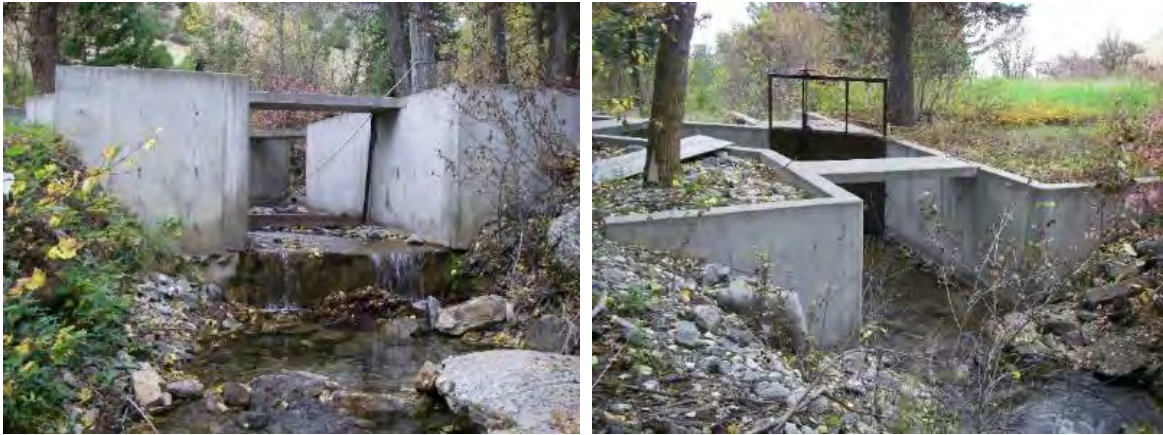
## **Bostwick Creek fish barrier (019-2016)**

Bostwick Creek (Gallatin County) is a tributary to Trout Creek and the East Gallatin River near Bozeman that currently supports populations of brook trout, hybrid (westslope x rainbow) trout, and pure westslope cutthroat trout (WCT). Two years ago, pure WCT were moved from Bostwick to Placer Creek, also within the Gallatin watershed. Bostwick Creek likely still holds many pure WCT. This project modified an existing weir structure to create a concrete fish barrier and isolate WCT from non-native fish species (Figure 22). The biologist will perform fish removals upstream of the barrier for 2-3 years using intensive electrofishing methods. The goal is to preserve the native population.

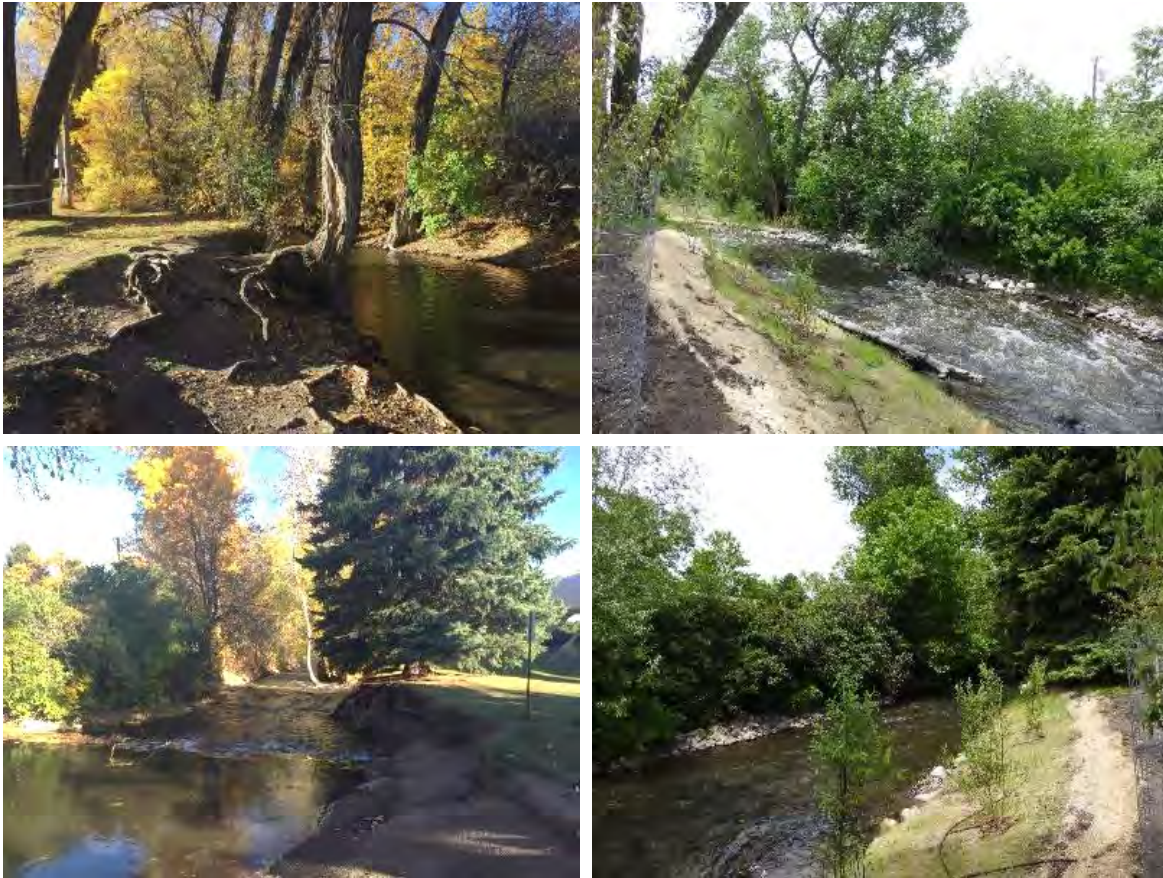
Bozeman Creek (Gallatin County) is a tributary to the East Gallatin River that supports a mixed salmonid assemblage. A portion of the stream, as it flows through Bogart Park within the city of Bozeman, was historically channelized. This reach of stream was entrenched with high, unstable banks, little hydraulic diversity and poor fish and wildlife habitat (Figure 23). This project realigned approximately 820 feet of the channelized stream to improve plan form, profile and cross-sectional characteristics. Additionally, an inset floodplain was constructed, and the riparian vegetative community was augmented. As part of the overall project, recreational amenities were installed to protect resources and better accommodate public use. The purpose of the project was to improve the stream, including nature-based recreation and environmental education purposes.

**FIGURE 23. BOZEMAN CREEK RESTORATION BEFORE (L) AND AFTER CONSTRUCTION (R, 2017).**

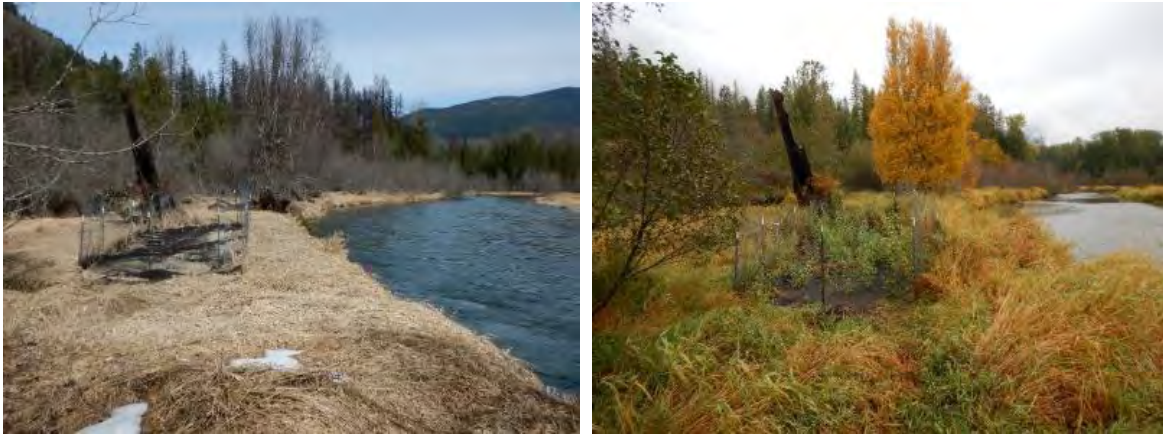
**FIGURE 24. BULL RIVER EXCLOSURE INSTALLATION (L) AND VEGETATION GROWTH (R, 2017).**

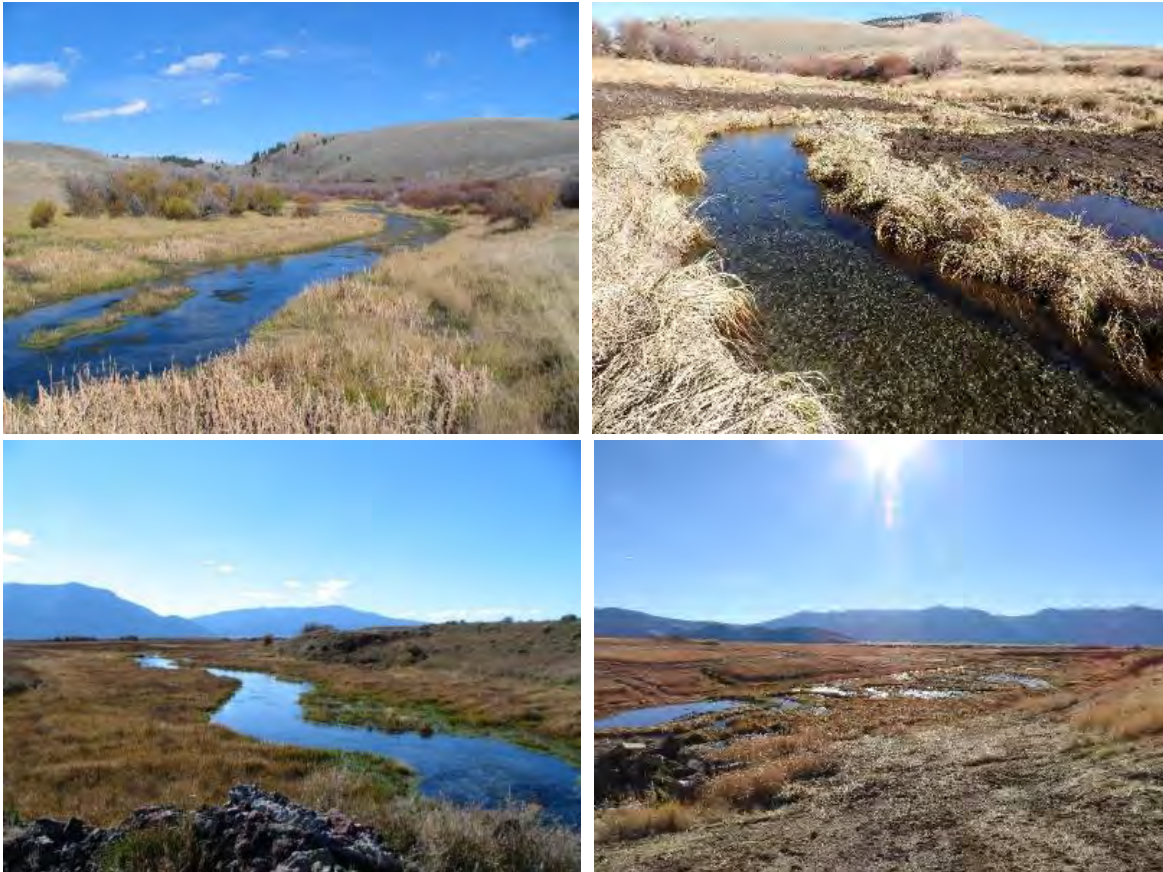
**FIGURE 25. ELK SPRINGS CREEK BEFORE (L) AND AFTER (R) CONSTRUCTION.**

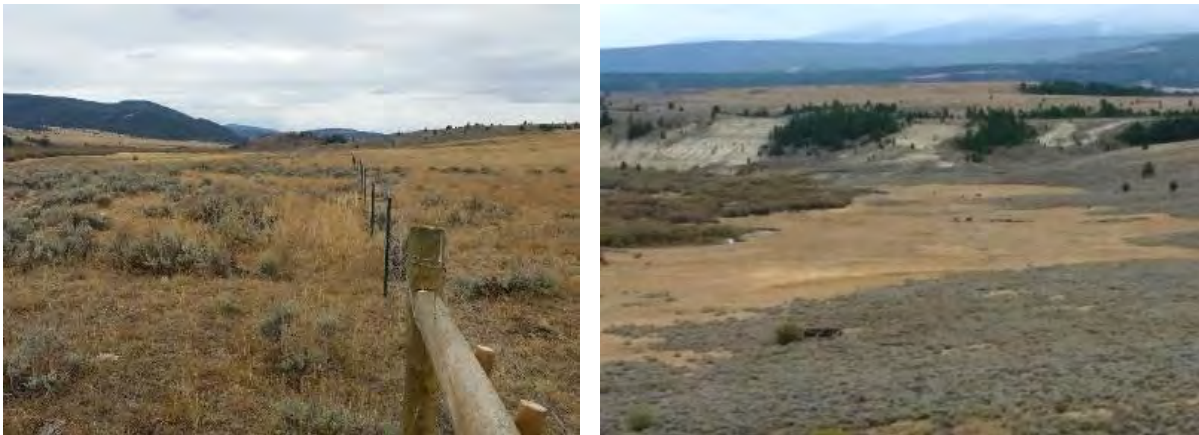
**FIGURE 26. FRENCH CREEK RIPARIAN FENCING POST CONSTRUCTION.**

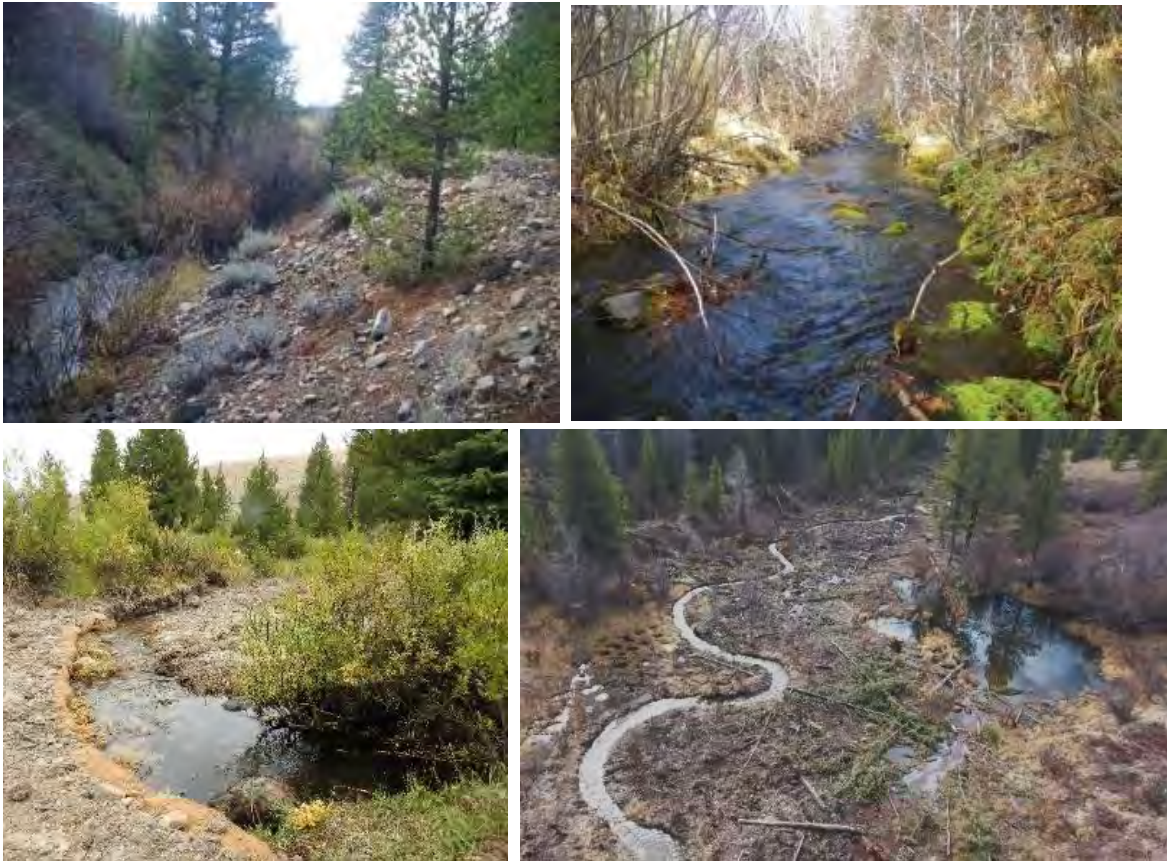
**FIGURE 27. FRENCH GULCH CHANNEL RESTORATION BEFORE (TOP) AND AFTER (BOTTOM, 2016).**

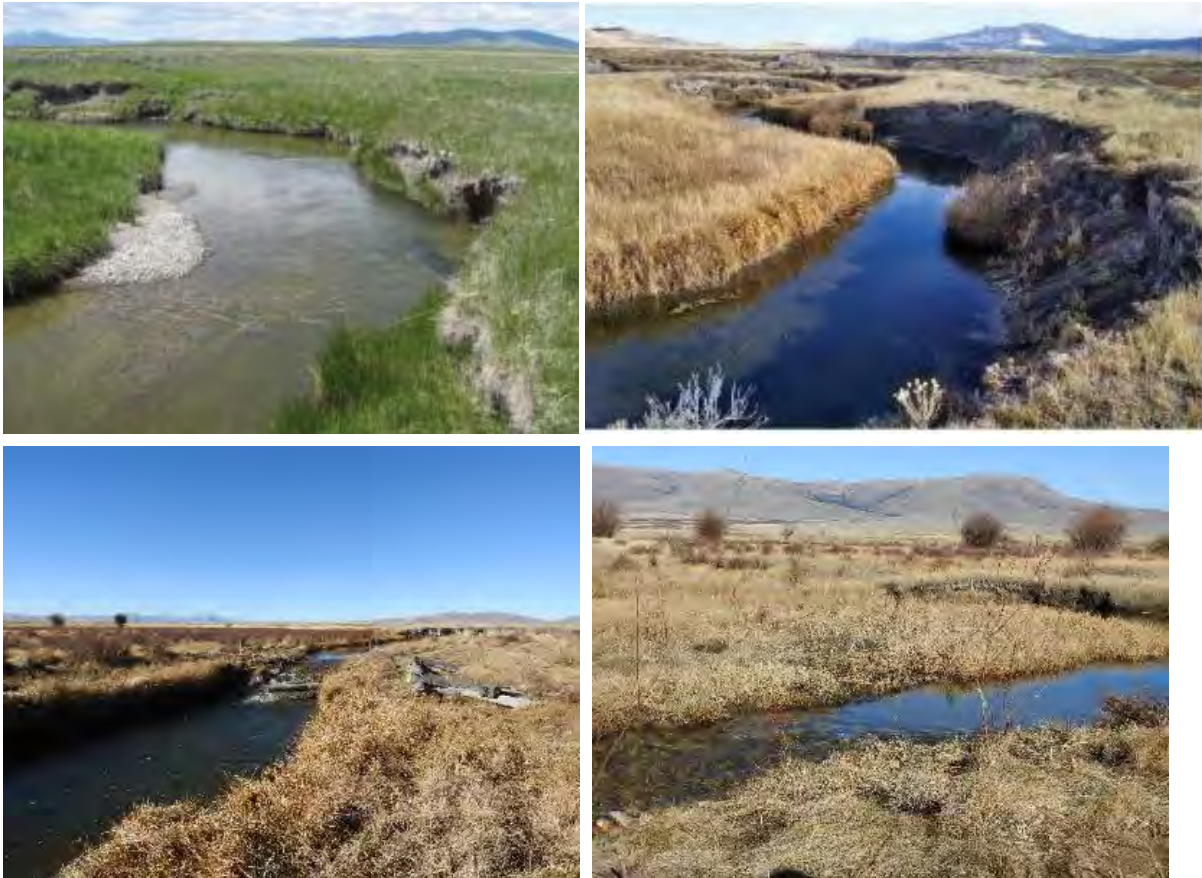
**FIGURE 28. LONG CREEK RESTORATION PROJECT BEFORE (TOP) AND AFTER (BOTTOM) CONSTRUCTION.**

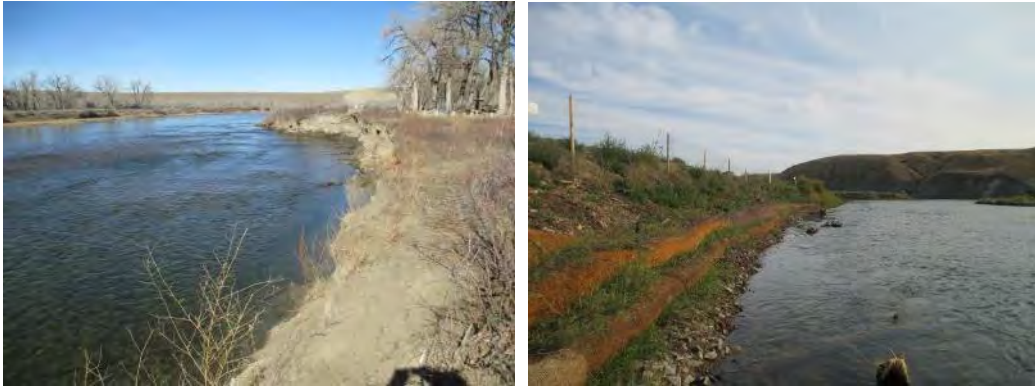
**FIGURE 29. MARIAS RIVER BEFORE (L) AND AFTER (R) CONSTRUCTION.**

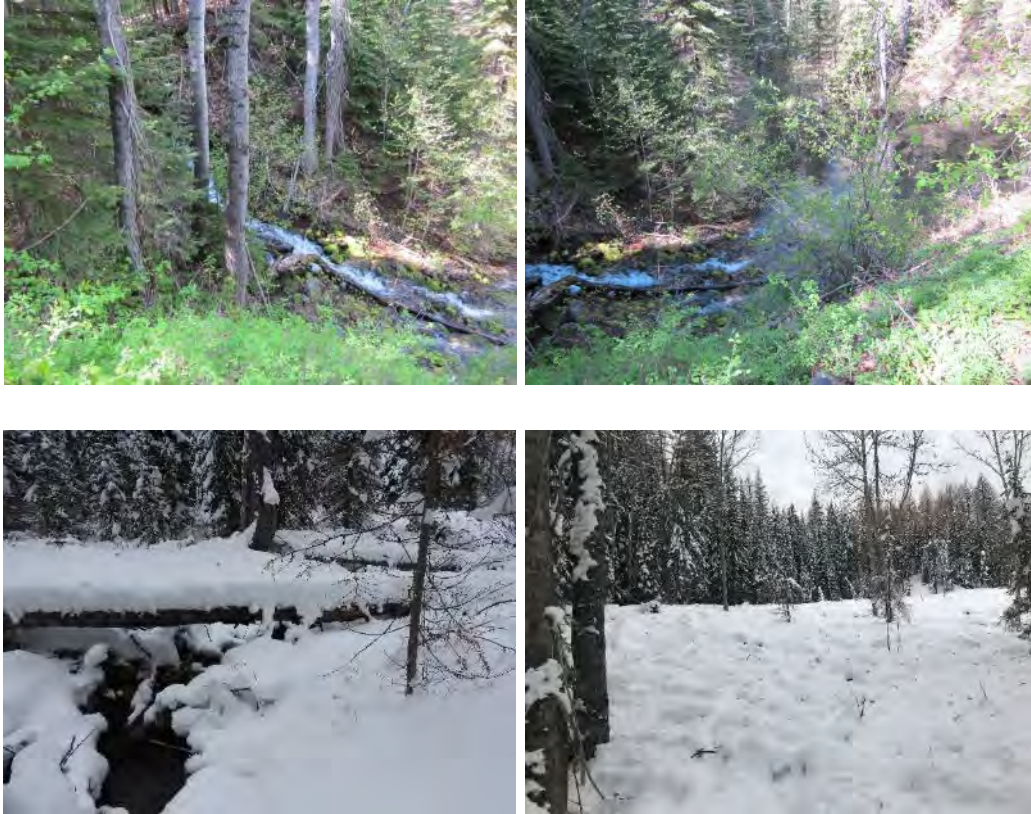
Martina Creek (Missoula County) is a tributary to Ninemile Creek and supports populations of westslope cutthroat trout and brook trout. It was heavily altered by mining and some logging, and the creek contains dredge ponds, cascading channels, and braiding. The impairments included impeded upstream fish migration, dredge ponds that contribute to increased water temperature, and placer mine tailings leading to sedimentation and impacted floodplains. This project addressed these issues by moving large piles of dredge mining tailings, filling mining cutslopes and dredge ponds, and reconstructing the stream channel to connect Martina Creek to Ninemile Creek (Figure 30).

**FIGURE 30. MARTINA CREEK; BEFORE CONSTRUCTION, THE STREAM WAS DIVERTED INTO A DREDGE POND (TOP) AND AFTER CONSTRUCTION THE STREAM WAS RETURNED TO ITS CHANNEL (BOTTOM L), WITH THE POND FILLED (BOTTOM R).**

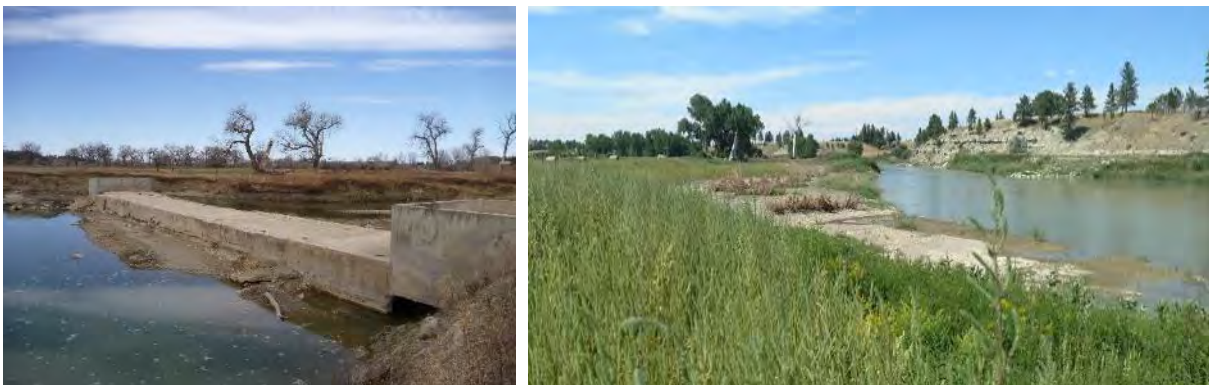
The Egge Diversion (Golden Valley County), on the Musselshell River, was in place for nearly 100 years. A 2011 flood flanked the diversion and led to severe erosion on the adjacent bank (Figure 32). This project maintained the recent connectivity in the Musselshell River by removing the fish barrier and allowing natural streamflow, opening a continuous 24-mile reach for passage and connecting the tributaries Big Coulee and Painted Robe Creeks, which contain species of concern northern redbelly dace, hybrid finescale dace, spiny softshell turtles, and many other native species. Fatmucket clams are also found in this area. The erosion on the adjacent bank was repaired using bioengineered soil lifts instead of rock riprap and was one of the first major bioengineering efforts in Eastern Montana.

**FIGURE 32. PRE-PROJECT FLANKED DIVERSION (L) AND POST PROJECT RESTORATION (R) ON THE MUSSELSHELL RIVER.**

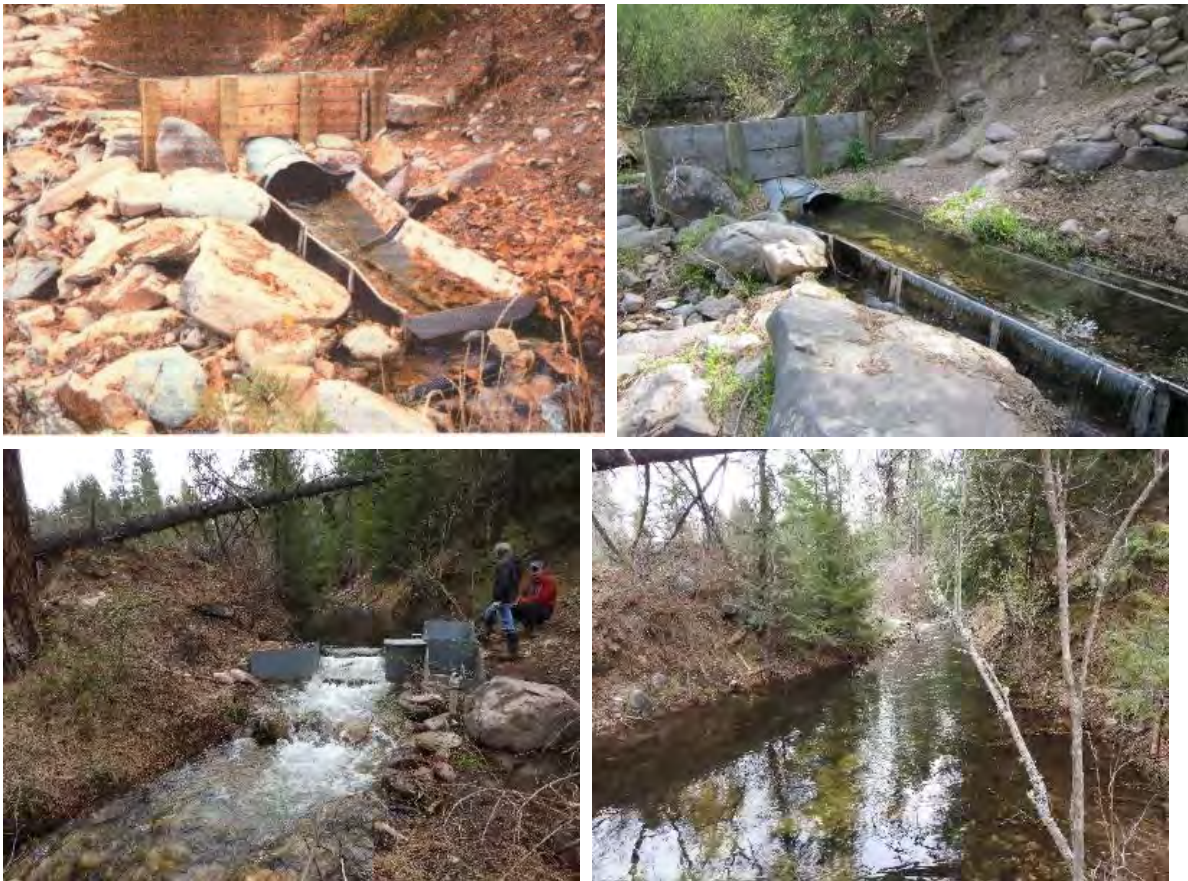
**FIGURE 33. RATTLESNAKE CREEK BEFORE (BRENCAIL-TYPE SCREEN, TOP) AND AFTER (COANDA-TYPE SCREEN, BOTTOM).**

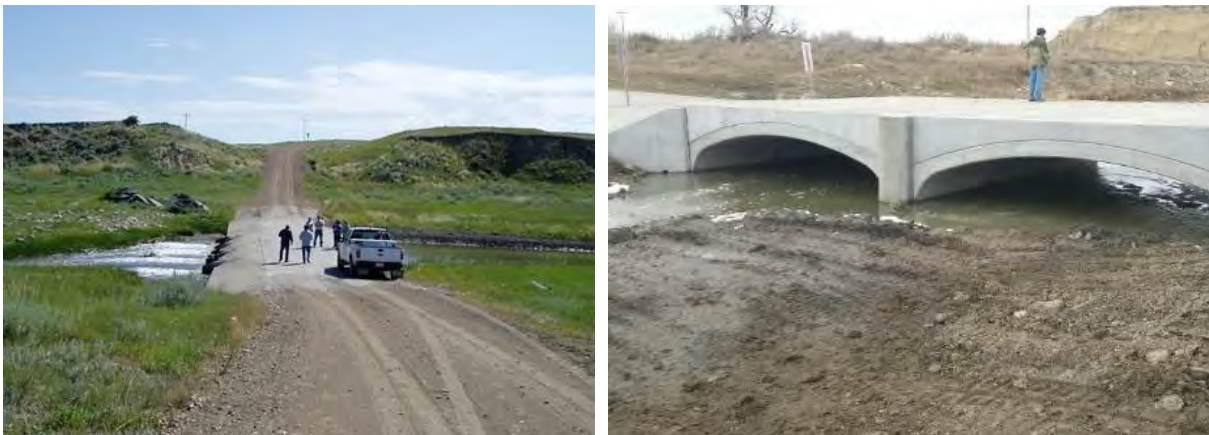
system. The Redwater River supports a very high diversity of fish species, including several Montana species of special concern (northern redbelly dace, sauger, Iowa darter and sturgeon chub). A county road crossing, the Nickwall Crossing, was acting as an upstream fish passage barrier most of the time. This crossing currently consisted of four, 24-inch diameter, concrete culverts spaced across the stream and were perched above the streambed (Figure 34). The road crossing, located about 1.25 miles upstream from the confluence with the Missouri River, essentially blocked upstream fish passage to about 25 miles of river habitat. This project re-constructed the stream crossing by installing four 12-foot wide by 5-foot tall box culverts. The new culverts were embedded below stream grade by about one foot and were backfilled with gravel to provide resting areas for slower swimming fish species.

FIGURE 34. REDWATER RIVER BEFORE (L) AND AFTER (R) CULVERT REPLACEMENT.

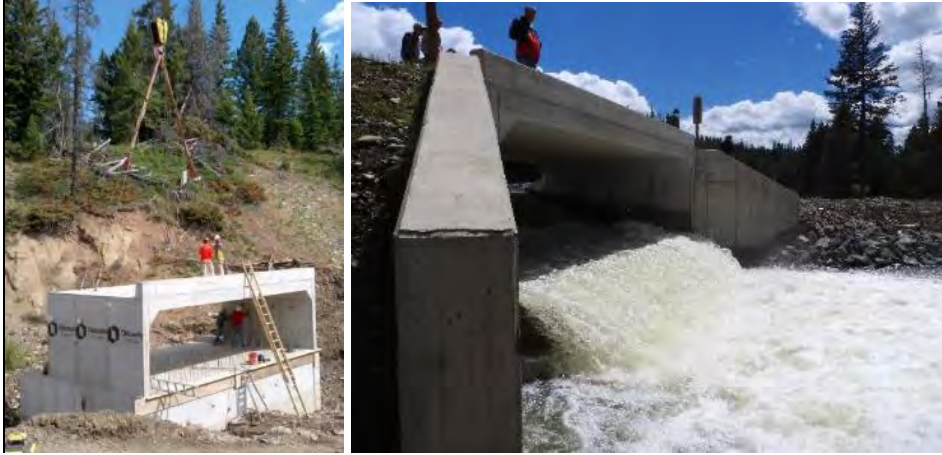
**FIGURE 36. SHIELDS RIVER FISH BARRIER DURING CONSTRUCTION (L) AND AFTER INSTALLATION (R).**

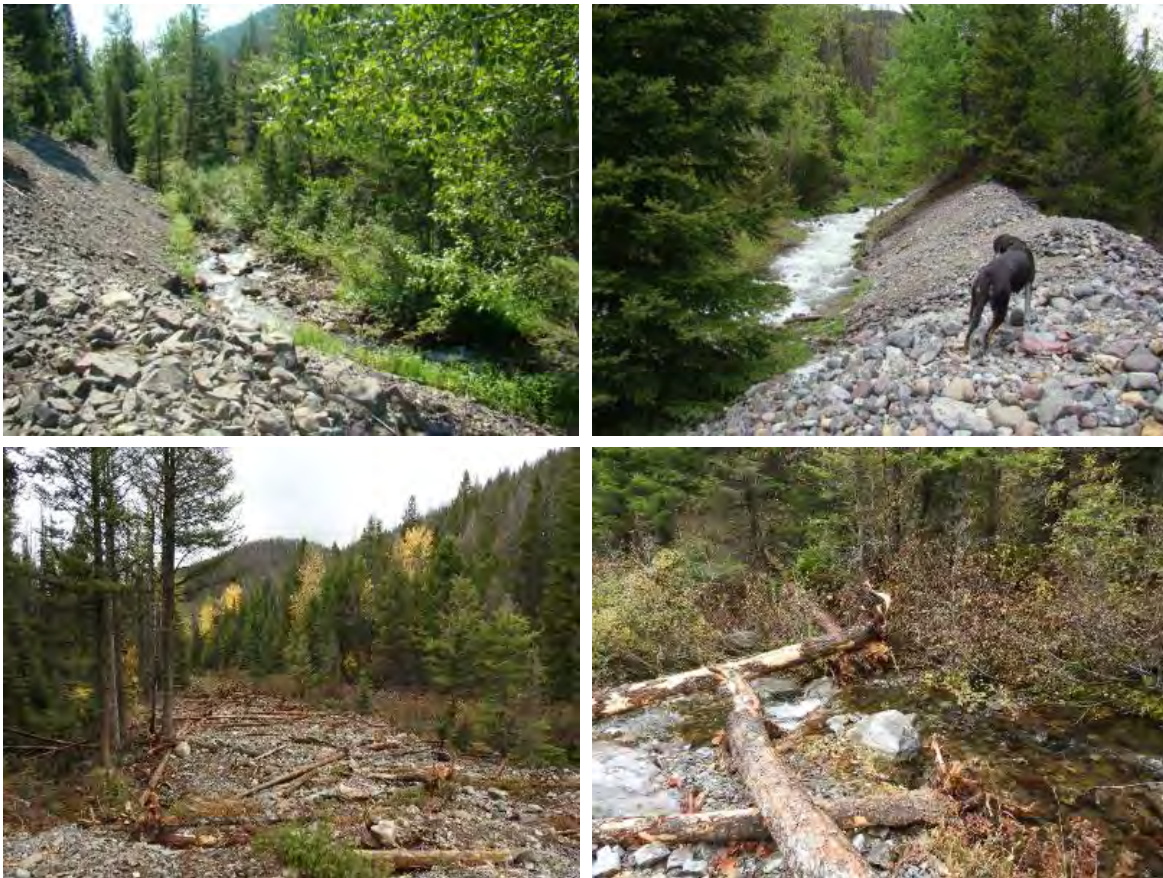
**FIGURE 37. STONEWALL CREEK PLACER TAILINGS (TOP) AND POST-PROJECT RESTORATION (BOTTOM).**

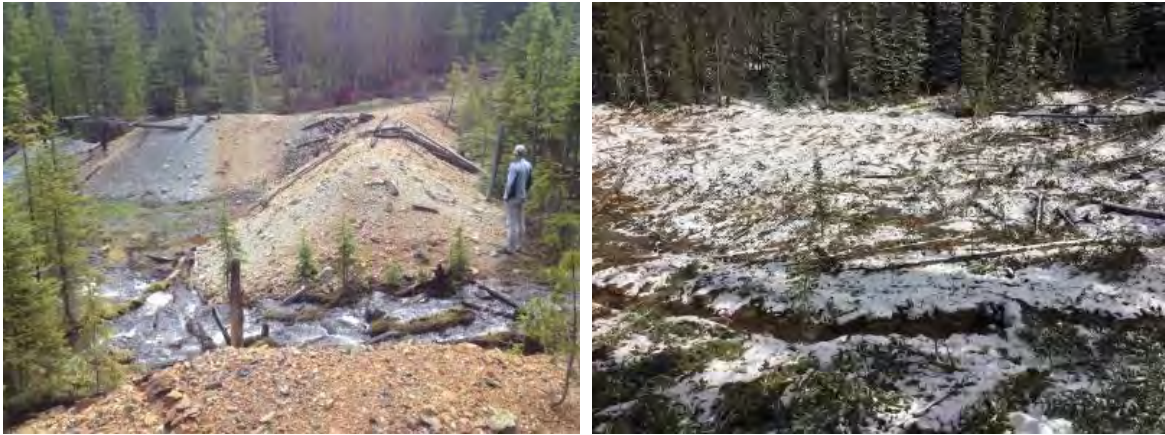
**FIGURE 38. TELEGRAPH CREEK TAILINGS (L) AND RESTORED CREEK (R). PHOTOS WERE TAKEN IN SAME LOCATION.**

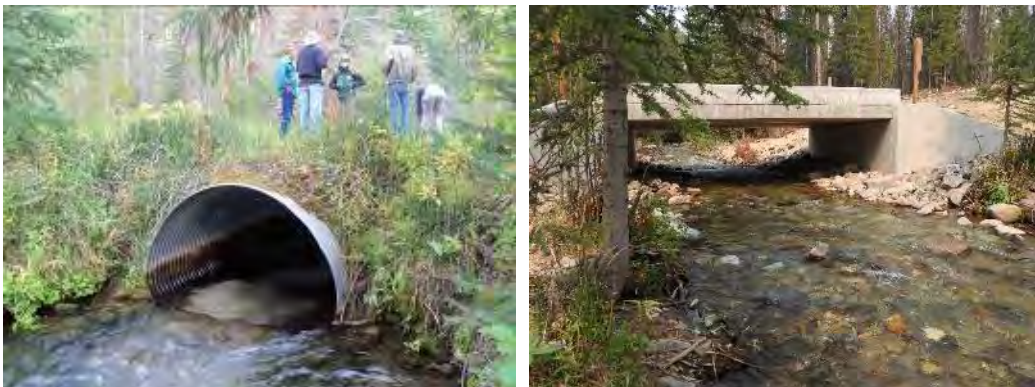
Warm Springs Creek (Deer Lodge County) is a tributary to the Clark Fork River within the Beaverhead Deerlodge National Forest that contains bull trout and westslope cutthroat trout. An existing culvert was undersized, acted as a velocity barrier for fish, promoted bedload deposition upstream, and increased scour downstream (Figure 39). This project replaced the undersized culvert with a precast concrete bridge. The goal was to replace the structure, thereby allowing unimpeded fish movement throughout much of the Warm Springs Creek headwaters and increasing access to 10 miles of habitat.

**FIGURE 39. WARM SPRINGS CREEK BEFORE (L) AND AFTER (R) CONSTRUCTION.**

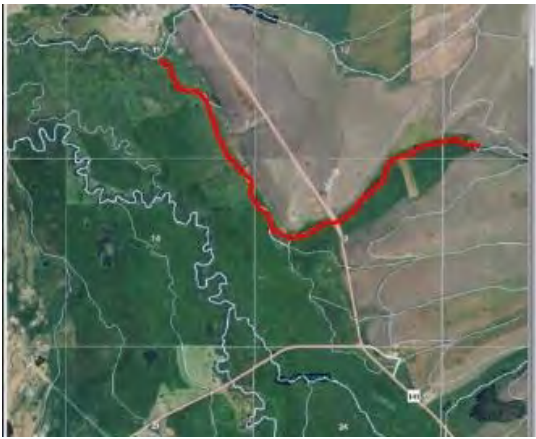
Creek hosts an isolated population of pure-strain westslope cutthroat trout. Irrigation on lower Wasson Creek dewatered the creek and the WCT were largely isolated from the rest of the drainage (Figure 40). High temperatures and lack of flow represented barriers to migration in and out of Wasson Creek. The instream flow lease achieved in 2007 led to a substantial success—in both reduced water temperature and increased numbers of WCT. Monitoring has also shown an increase in migration and spawning activity. This project renewed the instream flow lease and intends to continue the success in restoration for another ten years.

**FIGURE 40. WASSON CREEK INSTREAM FLOW IMPACTED AREA.**

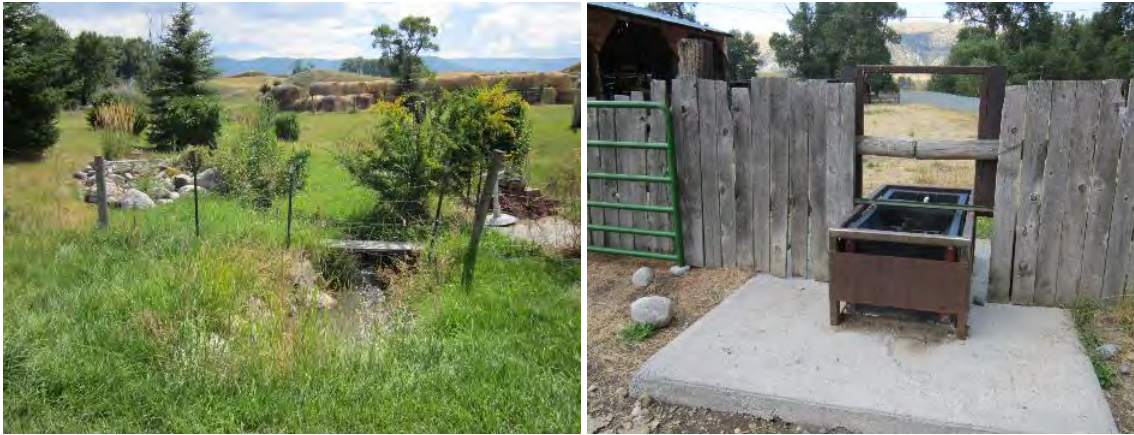
On August 16, 2017, Kyrsten Wolterstorff visited the project site to evaluate if the project was consistent with the FFIP application and to determine if the project had been beneficial to fish. Fencing had been installed, and cattle had no access to the creek. The riparian area was primarily a sedge community with little recruitment of riparian shrubs. Often, spring creeks do not provide suitable conditions for establishment of woody vegetation, so sparse woody vegetation was likely natural. The restored stream channel was relatively narrow and deep, consistent with a Rosgen E channel. The watering devices were in place; however, they were dry, as cattle were not currently occupying the corrals.

**FIGURE 45. CURRENT VIEW OF THE RELOCATED SPRING CREEK (L) AND EXAMPLE OF AN OFF-STREAM WATER SOURCE FOR CORRALS INSTALLED AS PART OF THIS PROJECT (R).**
